## **2022 Annual Dam Inspection Bailey Dam – Washington County Montpelier, Vermont**

**Project Owner / Local Sponsor: State of Vermont  
Agency of Natural Resources  
Department of Environmental Conservation**

Date of Inspection: 5 October 2022  
Date of Report: 19 January 2023

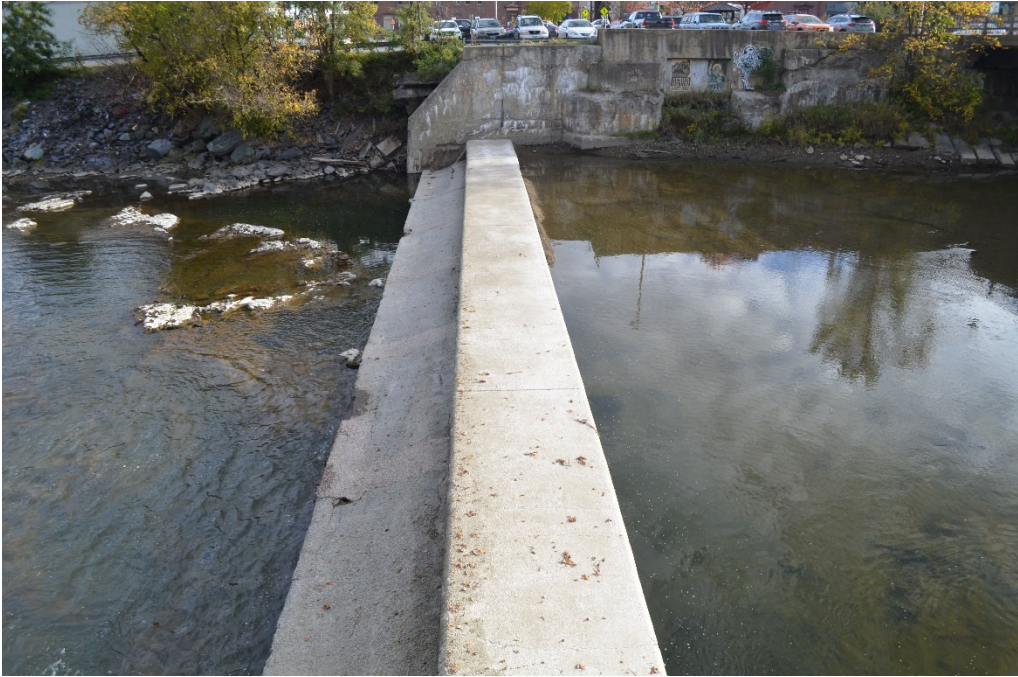
Numerous cracks and spalls were observed on the top of the crest (Photo 1). The cracking appears to be about the same as noted in the previous inspections when the crest was observed in 2012 and 2018 (Photo 2 from 2020 Inspection). It is recommended to monitor the concrete surfaces for additional cracking during lower water levels and to remove the accumulated debris from the dam crest on a regular basis.

Description:  Dam overview, viewed from left abutment.			
Date: 10/05/22			
Photo Number: 1			
Photographer: S. Sedwick			
Orientation: SW

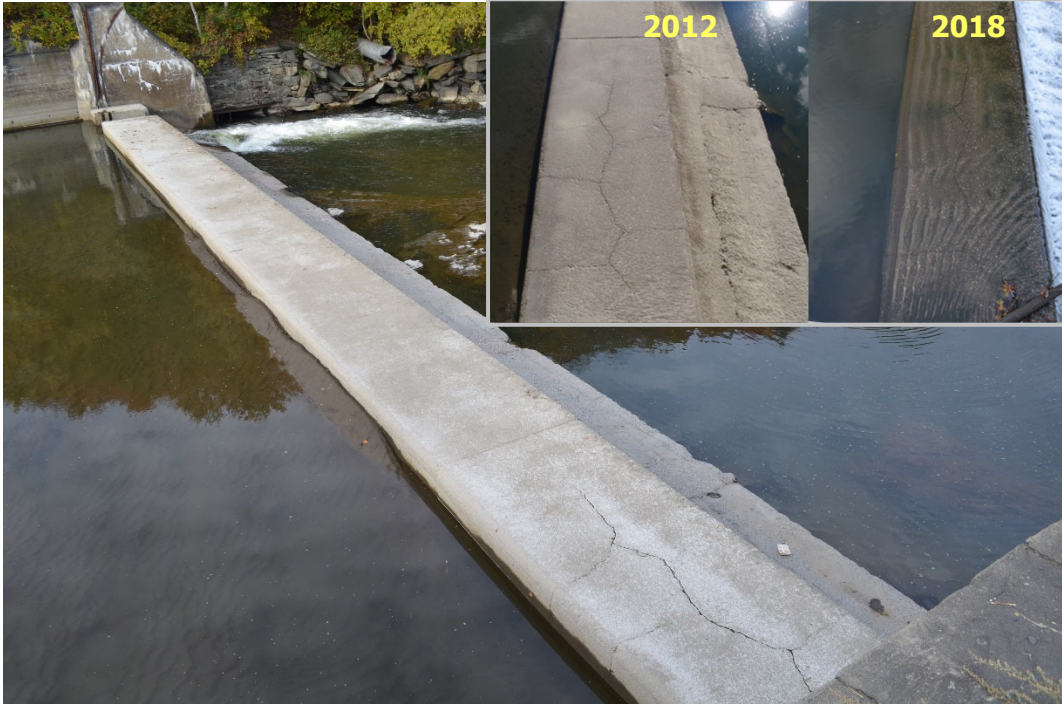
Description:  Cracking on spillway crest: 2012, 2018, and 2022.			
Date: 10/05/2022			
Photo Number: 2			
Photographer: S Sedwick

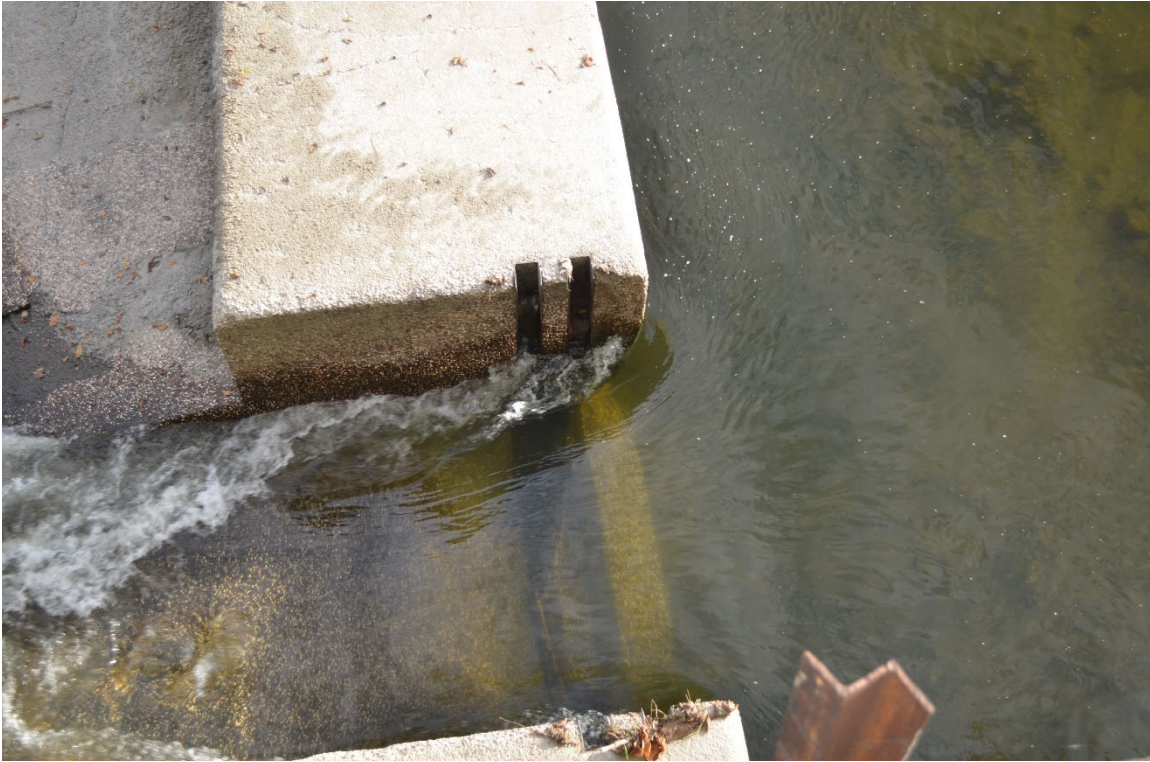
There is an 8-foot wide by 5-foot high stop log slot located adjacent to the left abutment. Most of the wooden stop logs have deteriorated and are no longer present. This results in a lower upstream pool, and concentrated flows with high velocities, even during periods of

low flow as experienced during the 2022 inspection (Photo 3). Due to kayaking and canoeing activity upstream of the dam, this is seen as a potential safety hazard to individuals utilizing the river for recreation. It is recommended, from a public safety perspective, that warning buoys and/or signage be added to alert people of the hazard.

Description:  Stop log slot during 2022 inspection. Upper stop logs have deteriorated and are no longer present.			
Date: 10/05/2022			
Photo Number: 3			
Photographer: S Sedwick			
Orientation: Looking down

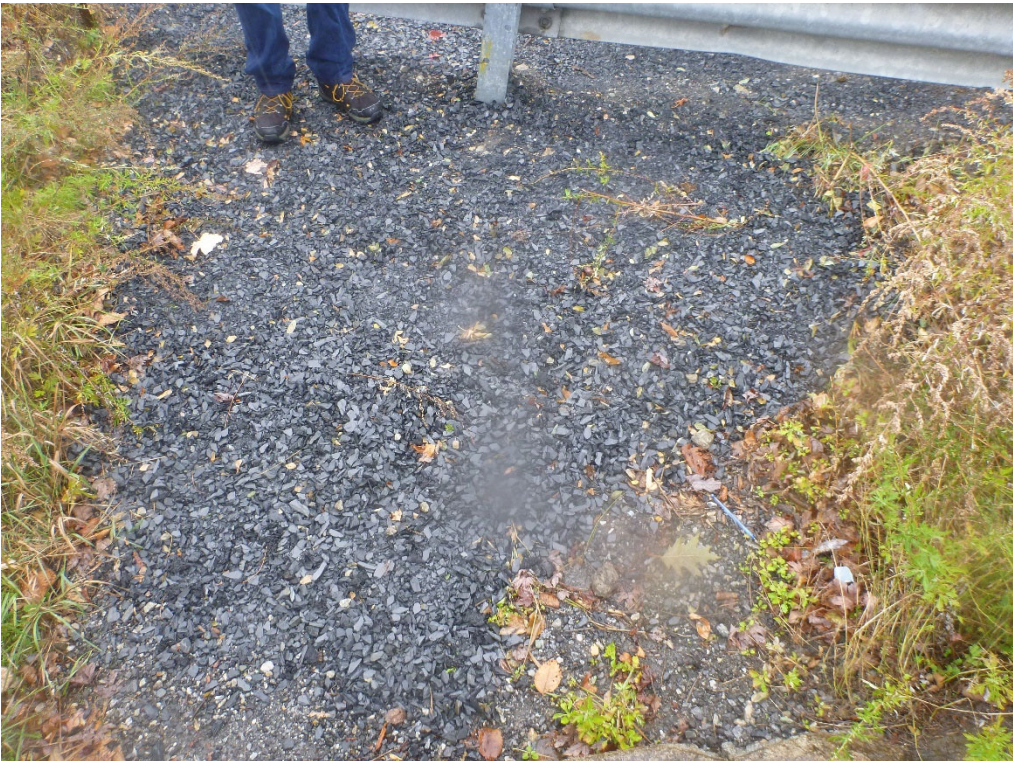
The right abutment is a 3-foot wide by 22.5-foot tall concrete retaining wall reportedly founded on bedrock which formerly supported the framework for the Tainter gates, which were removed in 1975. It now serves the purpose of retaining the existing grade of the adjacent commercial land use (currently a supermarket) parking lot. The wall is backfilled with concrete debris. The 3.5 foot by 4-foot diameter sinkhole directly behind the abutment caused by migration of soil through the large concrete backfill has been filled since the 2019 inspection (Photo 4). The concrete surfaces of the abutment contain cracking, efflorescence, and spalling (Photos 5 and 6). There is some erosion along the abutment moving downstream. The likely cause is from surface sheet flow coming from the adjacent parking lot. The sinkhole was the major safety concern from previous inspections, but this had been repaired prior to the 2020 inspection, and appears stable. No settlement was noted during this inspection, but this area should be monitored in future inspections. The concrete surfaces should be monitored for further deterioration.

Description:  Repair of sinkhole adjacent to right abutment.			
Date: 10/13/2020			
Photo Number: 4			
Photographer: C Hagerman

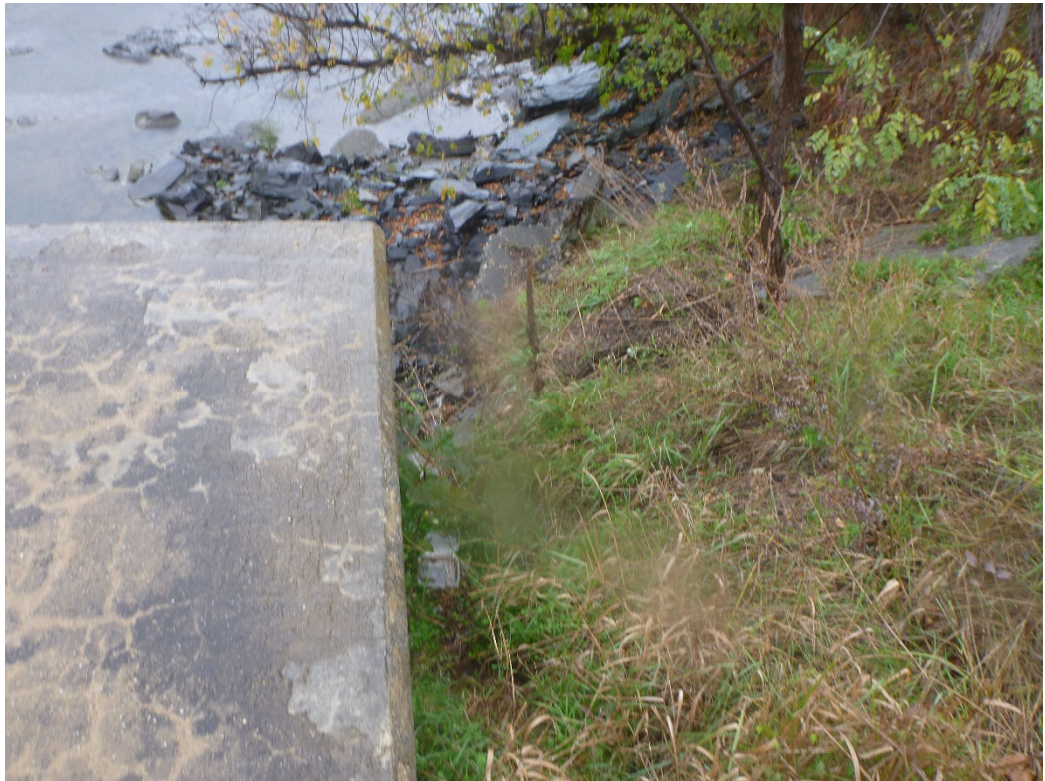
Photo Number:  
5

Cracking, spalling,  
and efflorescence  
on right abutment

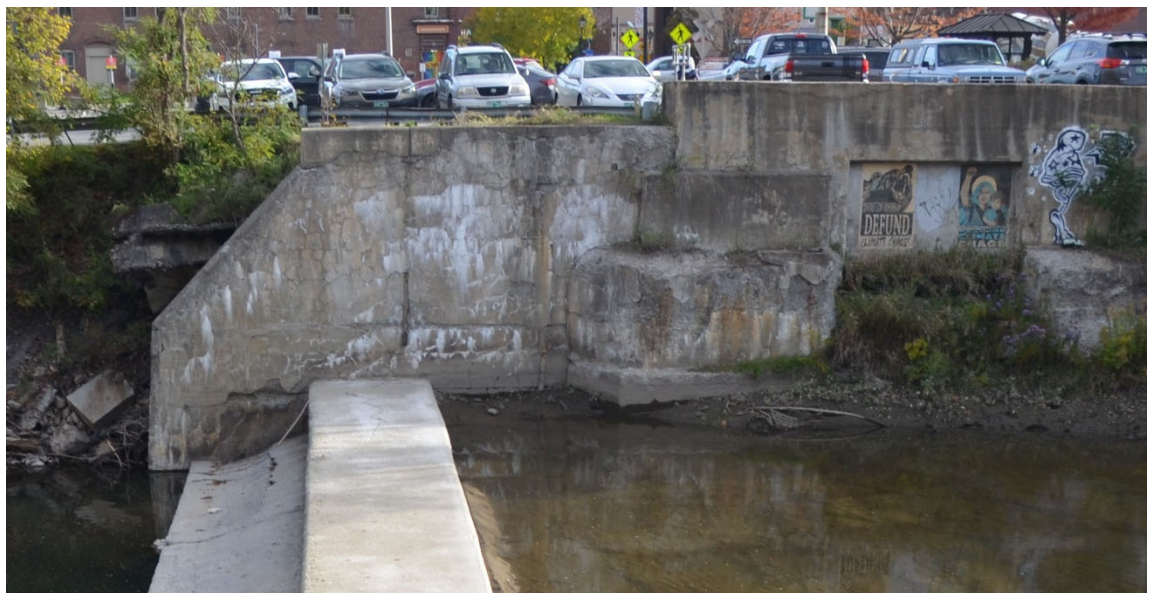
Photo Number:  
6

Cracking, spalling,  
and efflorescence  
on right abutment

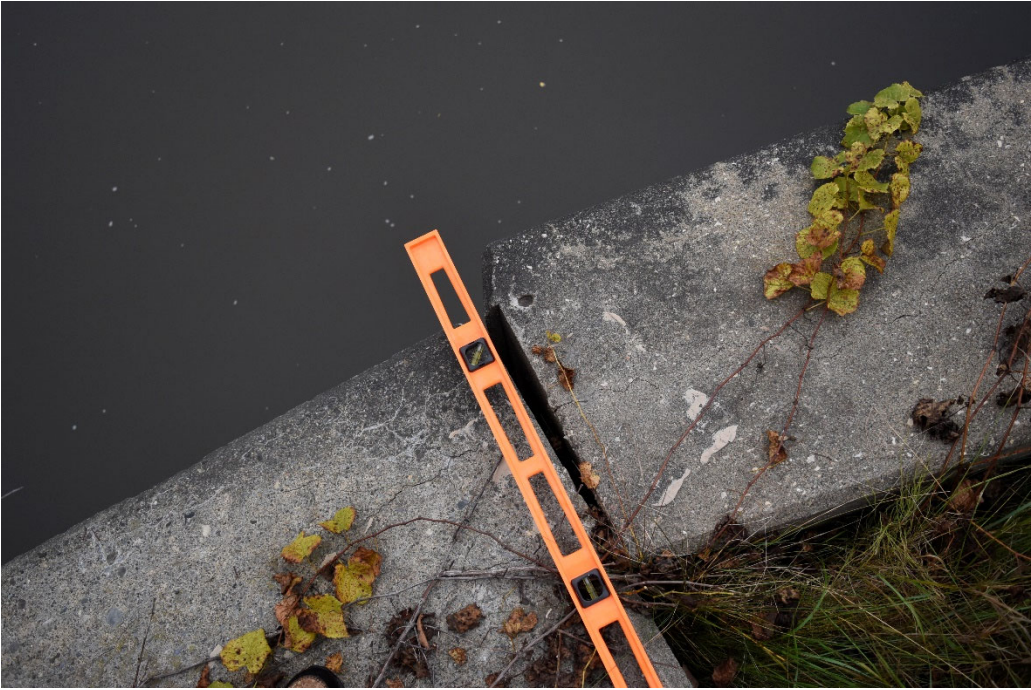
The left abutment is of similar construction to that of the right abutment with the addition of steel embedded parts for the former Tainter gates. Displacement of the upstream corner of the abutment was observed (Photo 7 from the 2019 inspection) is still present and has not increased in size. This displacement is located in a joint upstream of the dam abutment. Cracking, spalling, and efflorescence of the riverside concrete surface is present (Photo 8 and 9). It is recommended to monitor the concrete condition for further deterioration or displacement.

Description:  Displacement of the left abutment corner			
Date: 10/9/2019			
Photo Number: 7			
Photographer: J Gross			
Orientation: Looking D/S

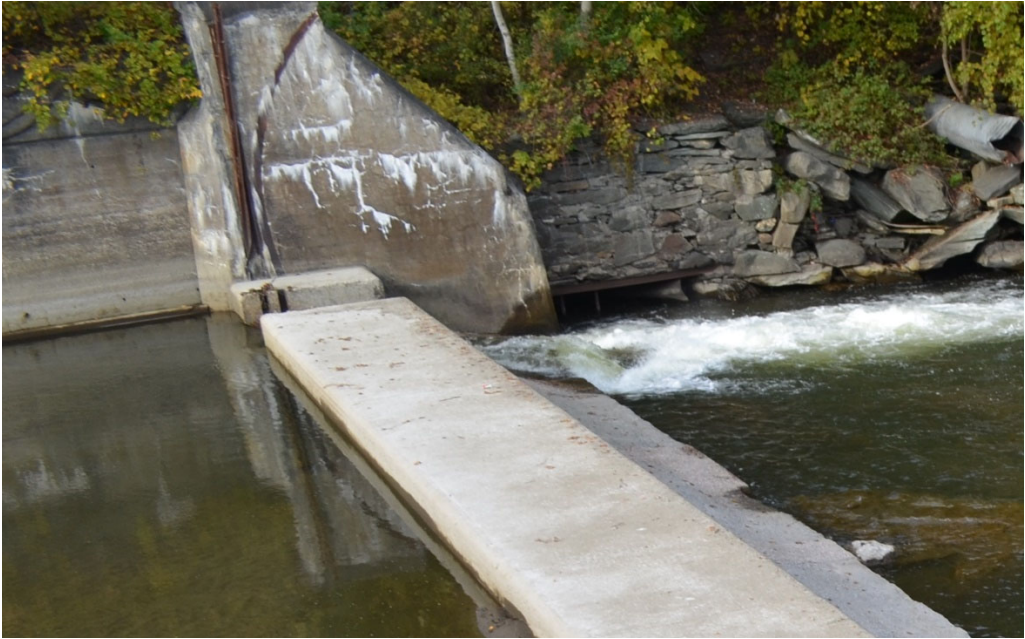
Description:  Cracking, spalling, and efflorescence on left abutment. Downstream rock wall deteriorating at drainage structure (non-project appurtenance)			
Date: 10/05/22			
Photo Number: 8			
Photographer: S Sedwick

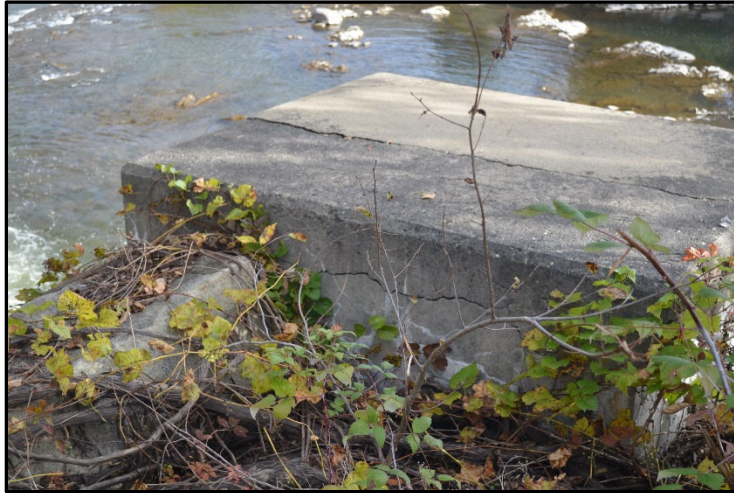
Cracking and  
spalling on left  
abutment.

Top of Left Abutment  
showing cracking

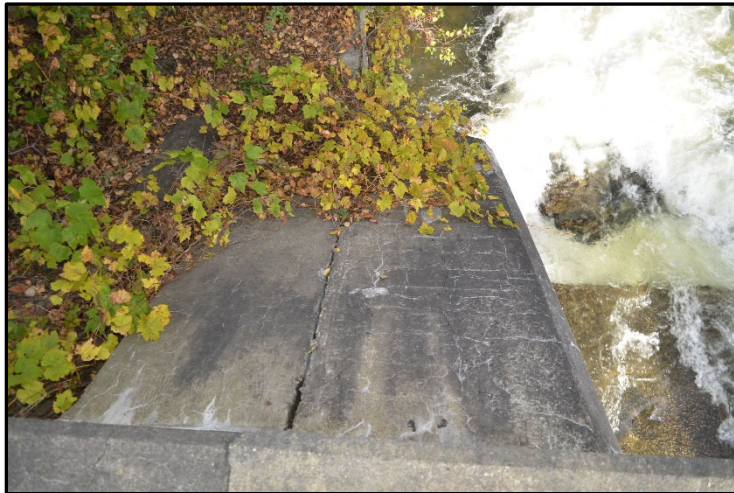
DS Side of Left Abutment  
showing vertical Crack
